MasterProtect 8000 CI

Longer Service Life of Concrete Structures with Proven Corrosion Inhibiting Technology

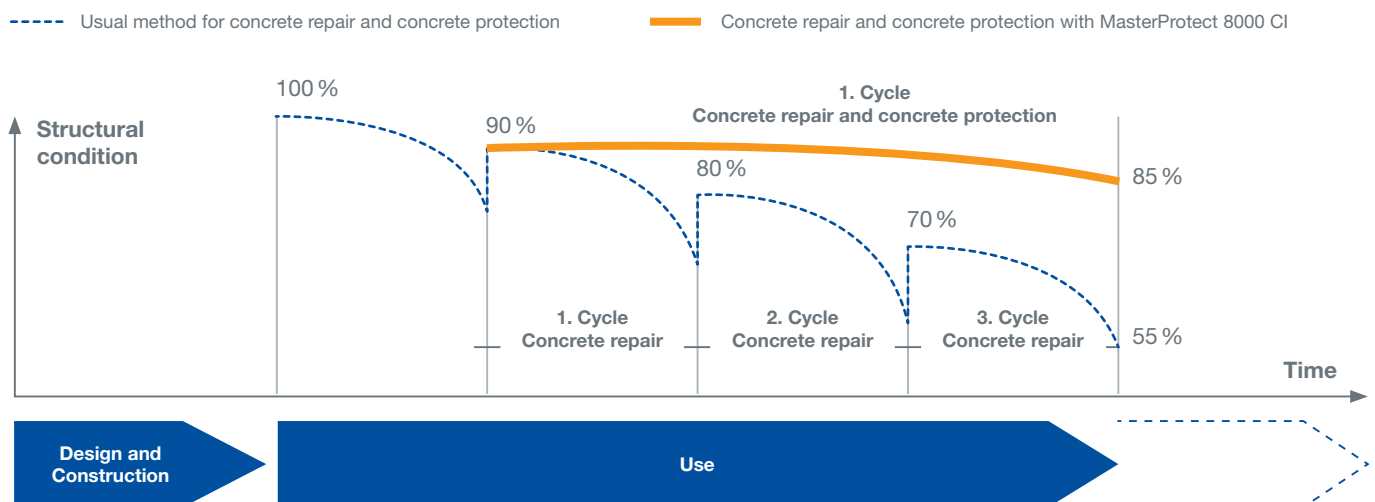
Example of interaction of protection materials and repair mortar (depends on project condition and is therefore different for each project).

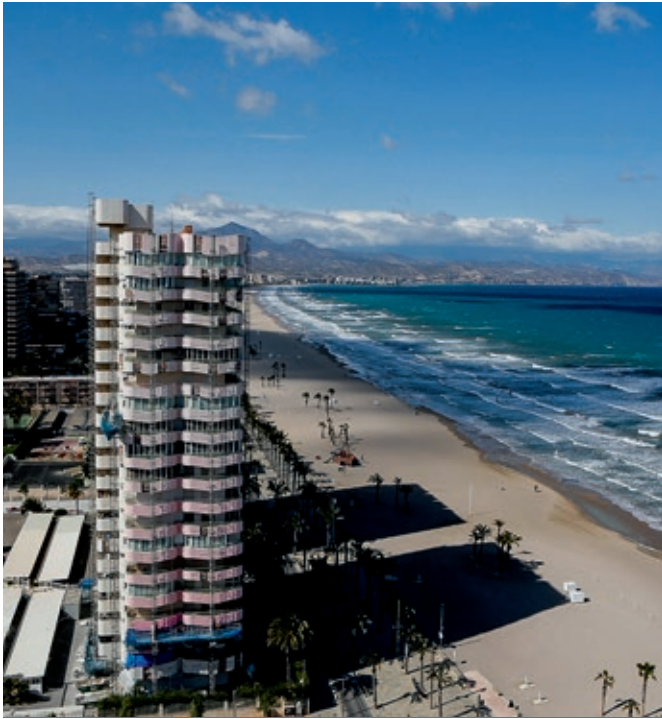
Buildings located in coastal areas

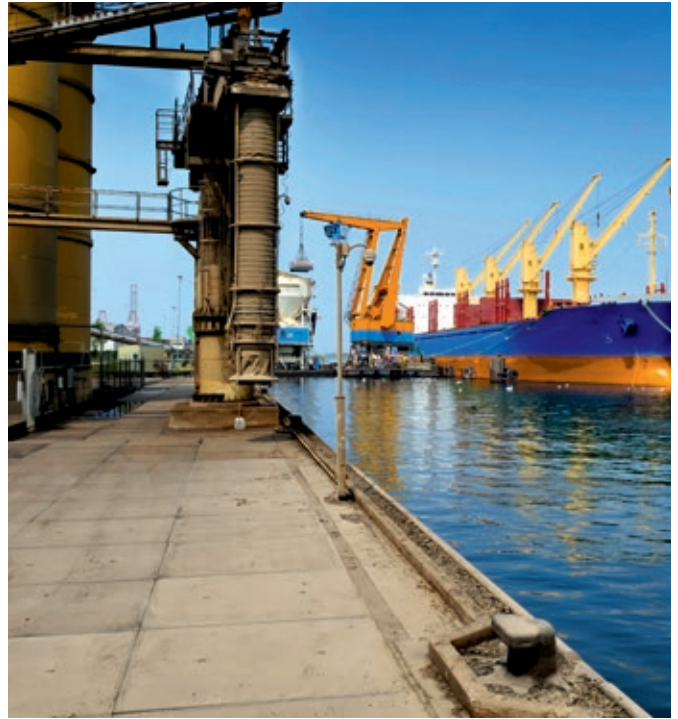
Typical marine structures such as quays, jetties, bridges in direct splash zones

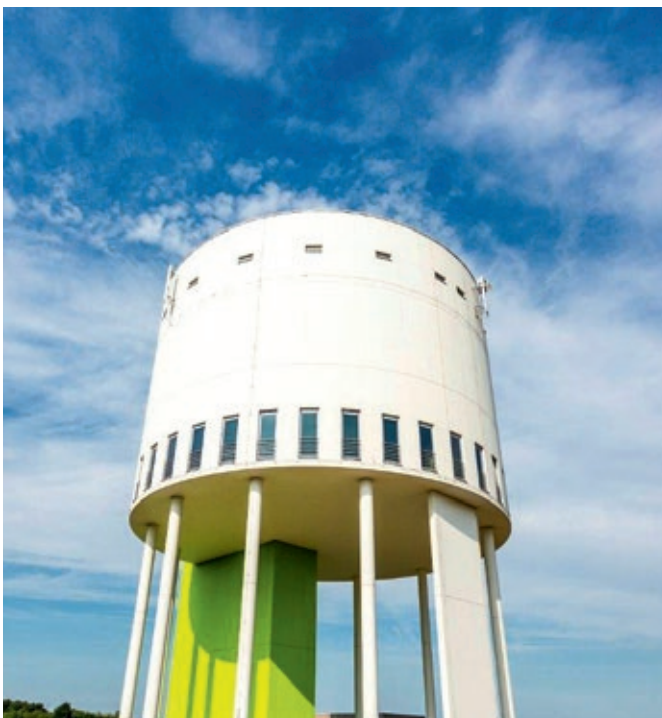
Industrial tanks, silos or pools in contact with chlorinated water or exposed to airborne salts

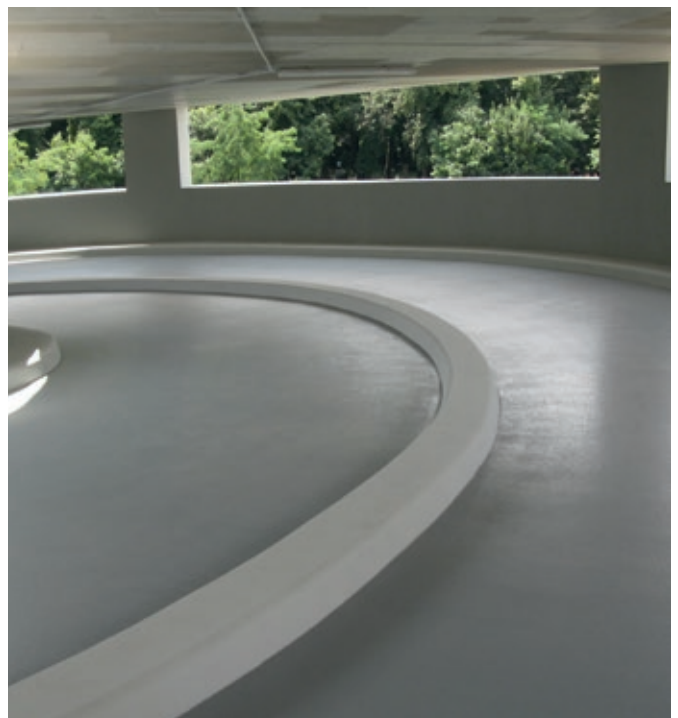
Areas exposed to heavy use of any de-icing agents (salts), e.g. parking decks

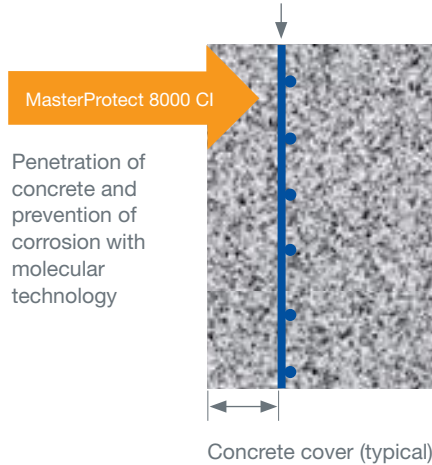
Steel reinforcement subject to potential corrosion reaction

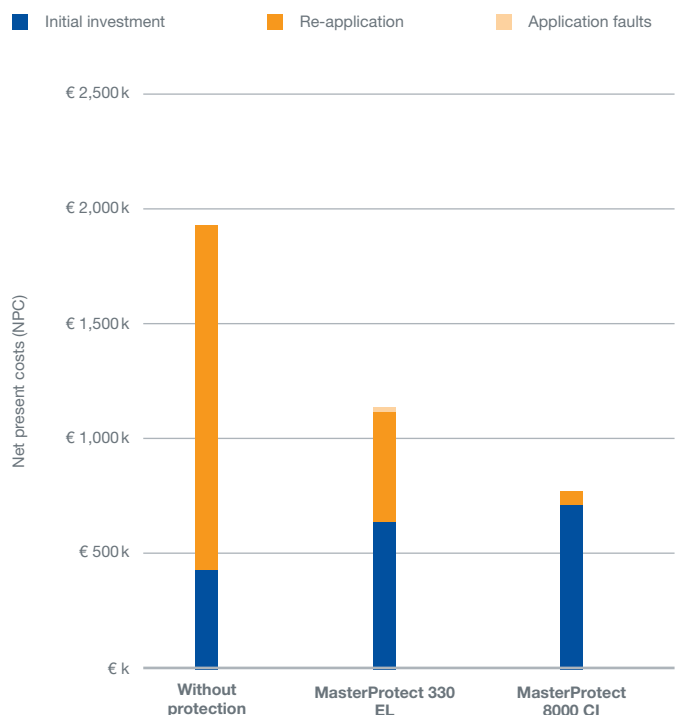
MasterProtect 8000 CI: Lowest overall cost

MasterProtect 8000 CI only needs to be applied initially and after 26 years

A direct comparison of the proposed protection methods compared with a standard repair and maintenance approach: The case study results presented in the graphs below are based on a silo refurbishment project where crack repair using MasterInject and structural repair with MasterEmaco mortars have been simulated. As a base case only the initial repair and recurring repair works have been modelled whereas with the MasterProtect 330 EL anti-carbonation coating and most favorable MasterProtect 8000 CI corrosion inhibitor, repair works will no longer be required in the future. MasterProtect 8000 CI – primarily due to its cost effectiveness – is the most preferable treatment in this case study.

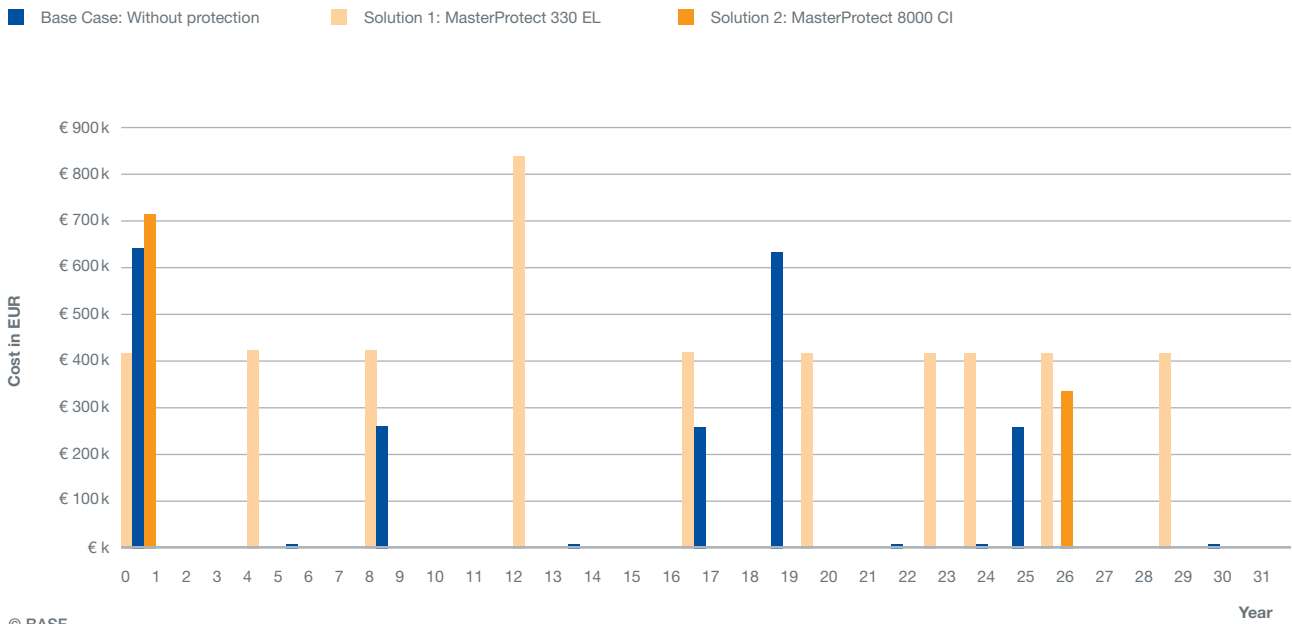
Yearly costs

Overview of the yearly expenditures associated with each option – adjustable to specific needs

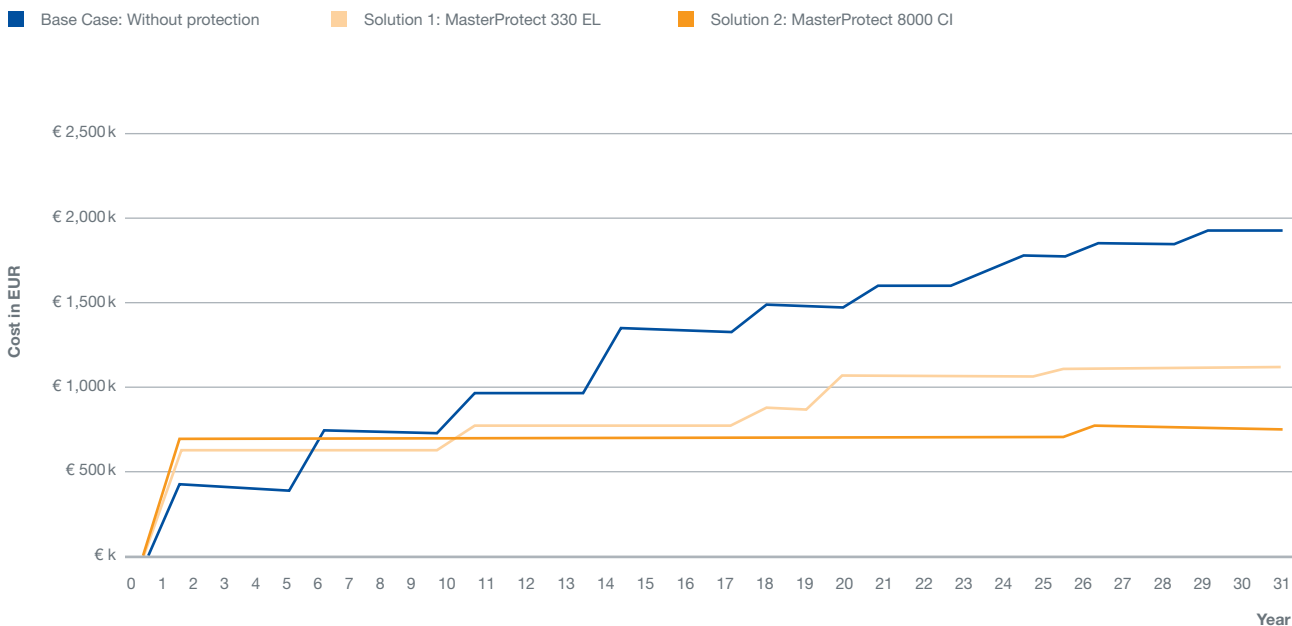
MasterProtect 8000 CI: High initial application costs, but most profitable solution in the long run

Cumulative costs (NPC)

Discounted net present costs to demonstrate the most cost effective solution as shown in the final life cycle cost report

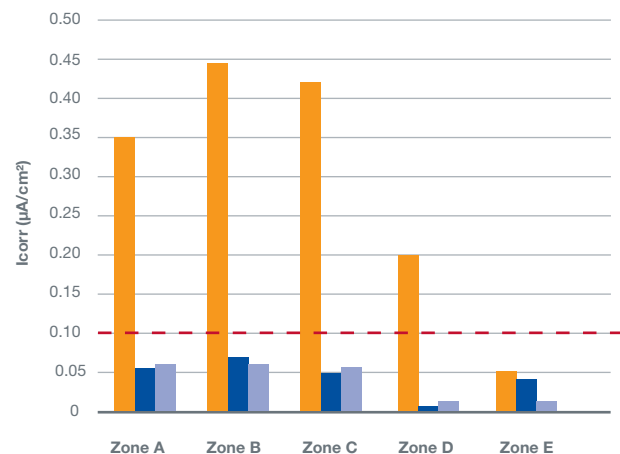
Performance of MasterProtect 8000 CI

■ Initial measurements before treatment
■ 7.5 years after application
■ 10 years after application
- - - Corrosion Threshold (above this value structure suffers from active corrosion)

The product was applied in 2005 and monitoring was carried out in 2007, 2013 and 2015, obtaining spectacular results even under adverse seaside climate and concrete carbonation related conditions.
